Straub Hall  
University of Oregon

# **Report #1**

## **Envelope Renovation Study**

September 2012

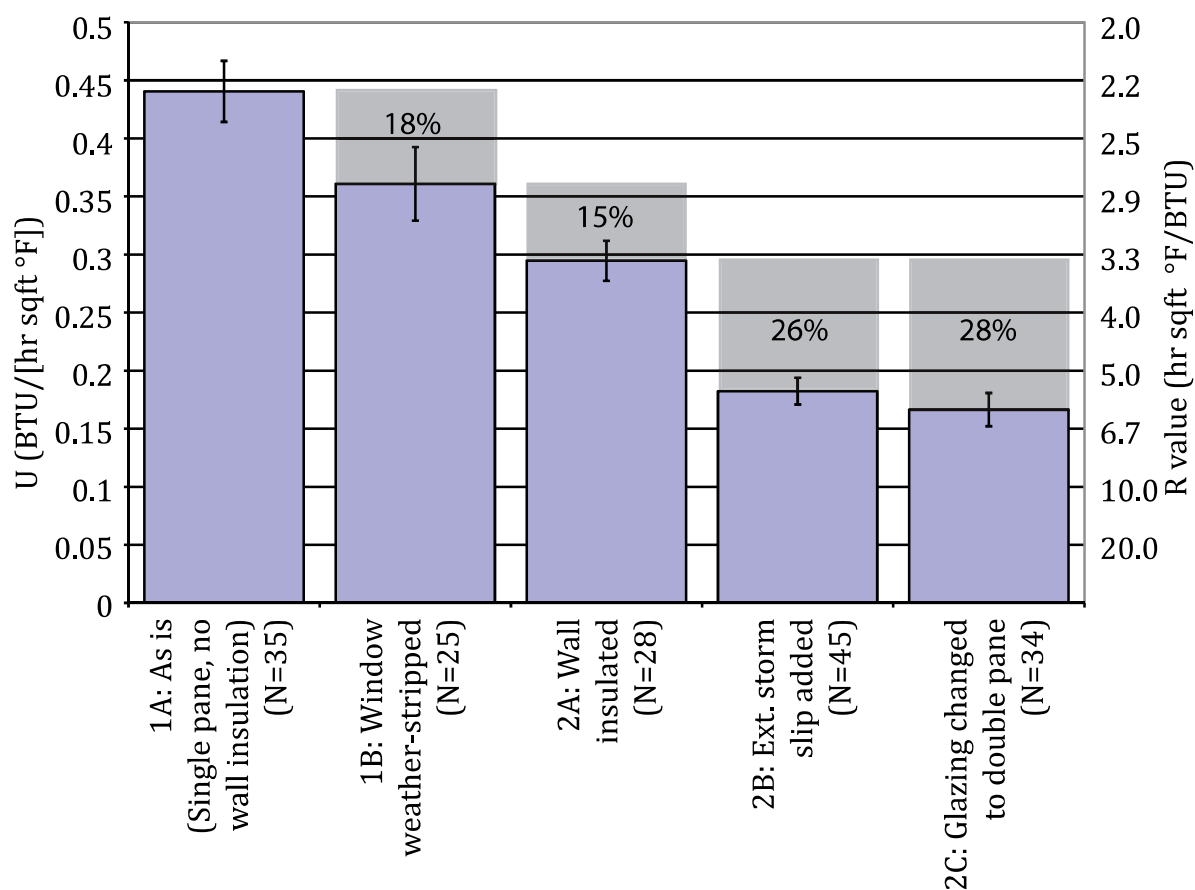
**Figure 3, Straub Coheating Summary**

The following chart (Figure 3) shows the change in performance for each of the window and wall improvements tested. It is specific to the window and wall area tested and does not represent the whole building. As seen in the chart, the overall U-value of the test window/wall assembly reduced 61%, from 0.44 to 0.17 BTU/hr-sf-°F, from the base case to the final configuration. The U-value reduction from baseline for each improvement is as follows: 18% for weather stripping, 15% for insulation, 26% for slips, and 28% for double pane. In other words, if only insulation would be added, the window/wall assembly would have a 15% reduction in U-value. Note that the double pane and the storm slip are alternates and only one of the two would be included; therefore, both are compared to Test 2A.

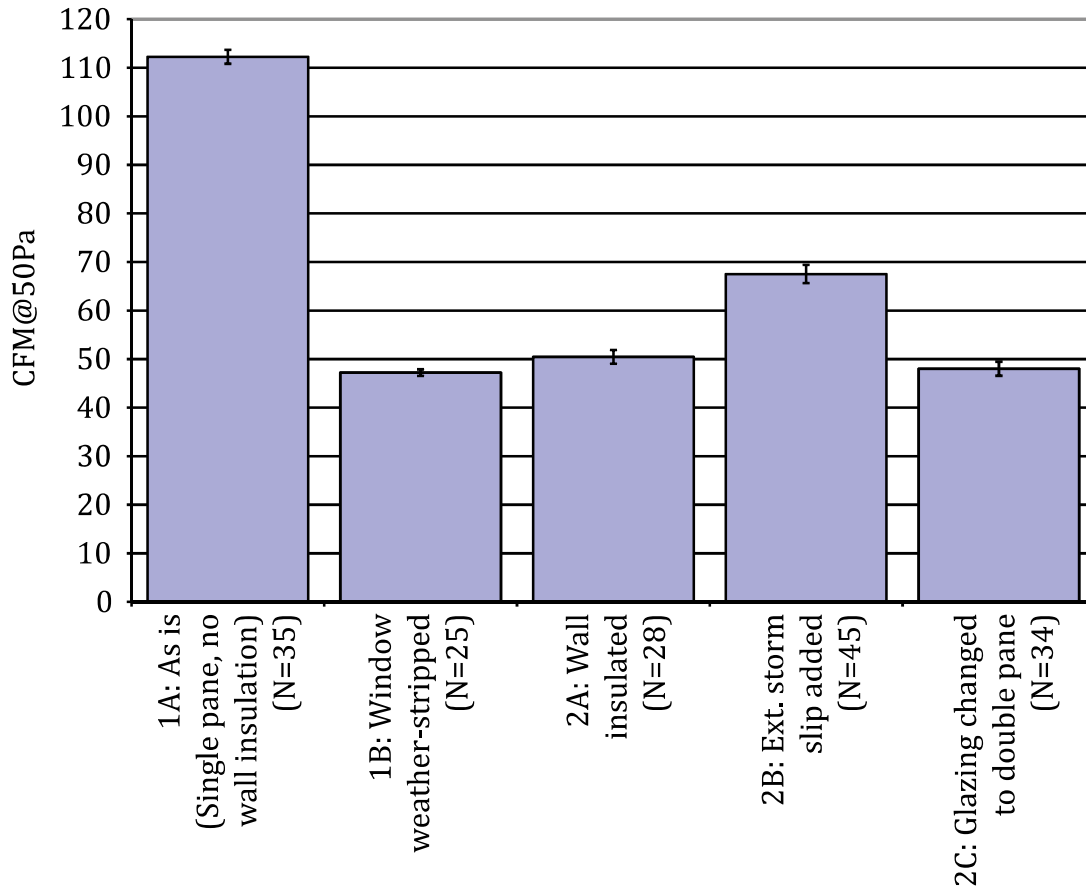
**Figure 5, Straub Blower Door Summary**

The following chart (Figure 5) shows the results of the blowerdoor tests. These values are airflow rates at 50 Pa and do not represent rates at usual wind pressures. Note that in Test 2B leakage increased for an unknown reason. Using sashes from another window may potentially have been the cause for this increase; note that the sash used for the slip test were taken from a neighboring window and may not have had a good fit in the test window. It is recommended that retrofitted sash units be replaced into their original frames.

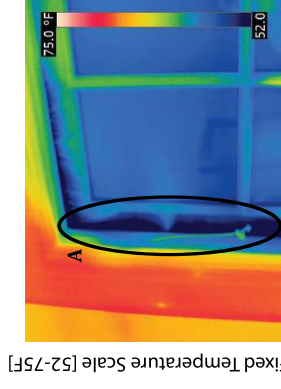
A: Infiltration noticed between sash and side jamb

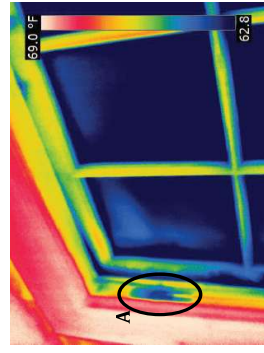
A: Need to seal counterweight pulley opening

The windows should be weather-stripped. If the existing sashes are to be used, it is recommended that retrofitted sashes be reinstalled into their original frames. Additionally, the counterweight cavity should be sealed as well as filled with insulation.

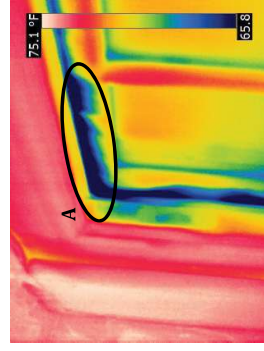
A: Exchanging sashes increased air leakage around window

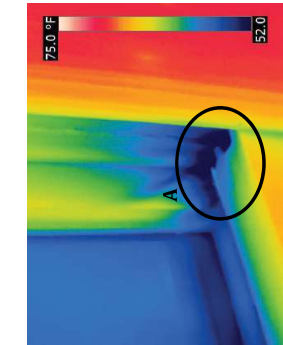
A: Noticeable infiltration in between check rails especially near the jamb

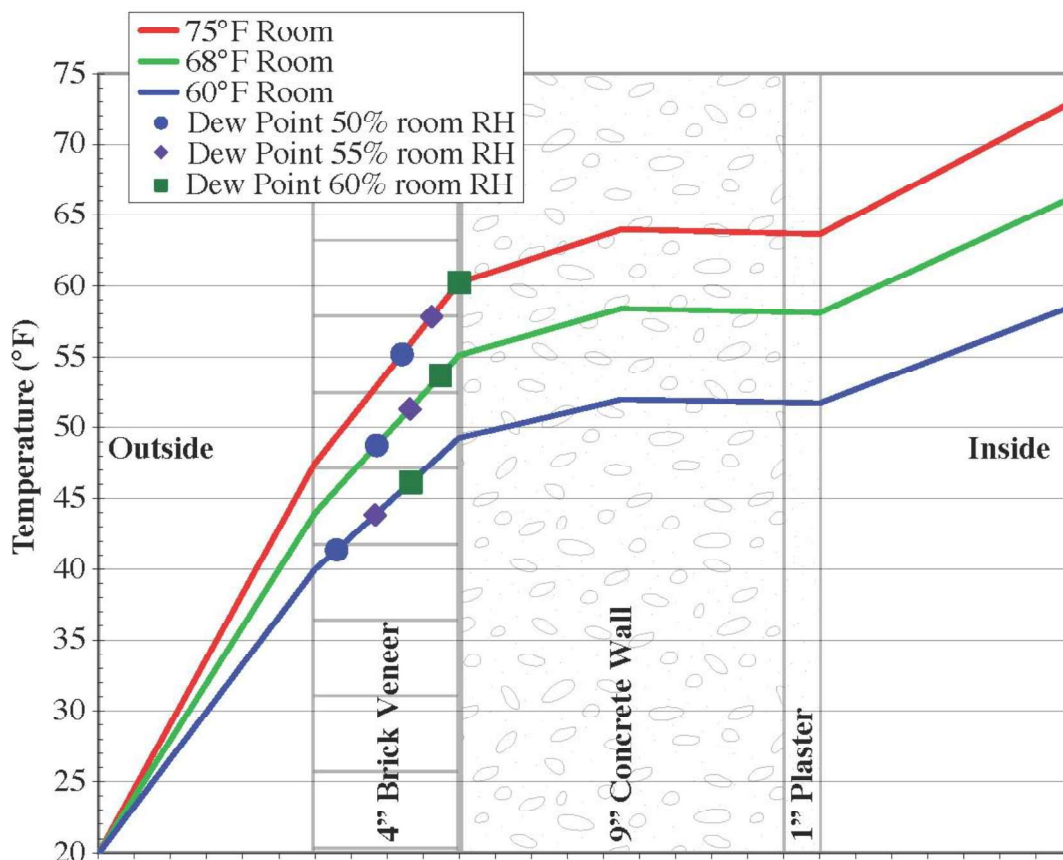
Figure 7, Non-insulated Wall Dew Point and Temperature Profiles

In the non-insulated wall, under operating conditions the dew point will likely occur between the outer surface of the concrete and the outer surface of the brick.

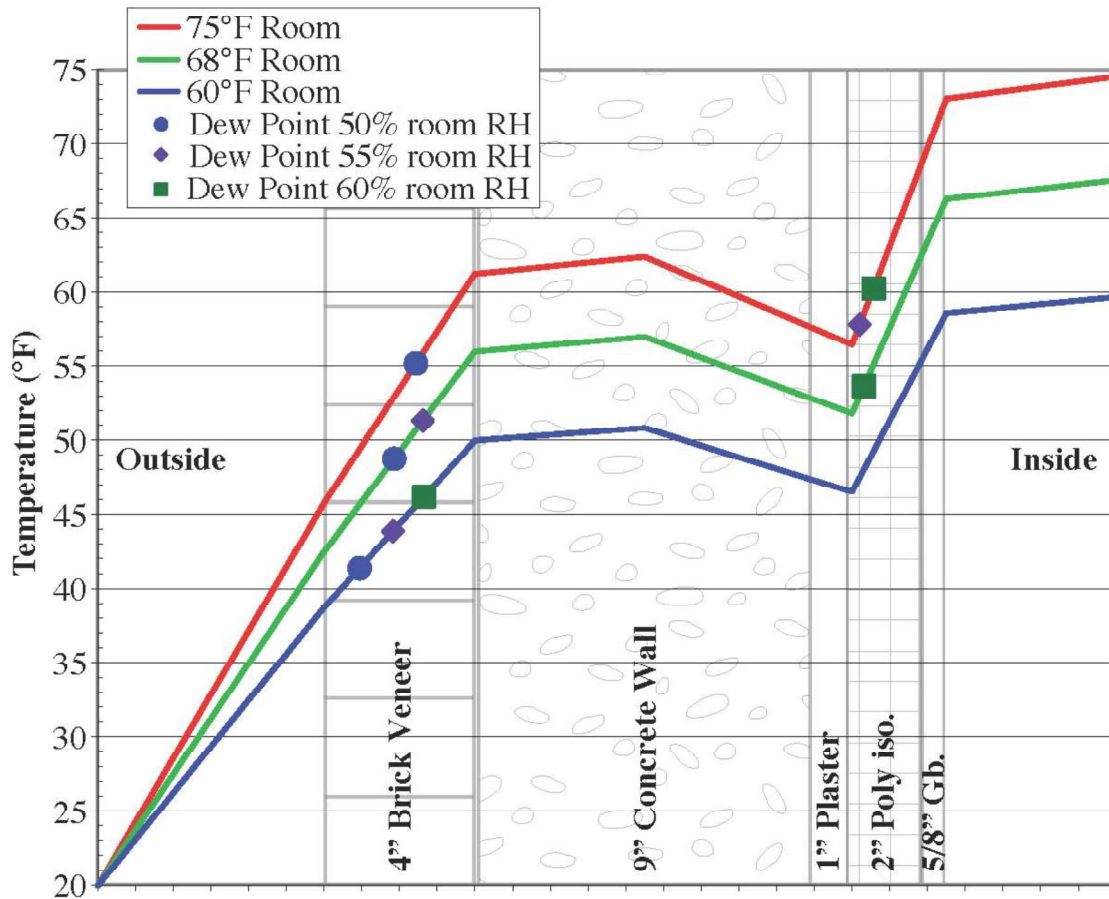
Figure 8, Insulated Wall Dew Point and Temperature Profiles

In the insulated wall the dew point occurs in the brick veneer with lower temperature/humidity conditions and between the finished wall and plaster in higher temperature/humidity conditions. With the dew point occurring inside the inner surface of the concrete under operational conditions, a vapor barrier should be added to avoid moisture build-up. The vapor barrier should be located between the interior atmosphere and the rigid insulation.

Insulation should be added to the exterior walls. Also, based on the wall monitoring results, a vapor barrier should be provided either on the inside finished surface of the wall or between the insulation and gyp board.

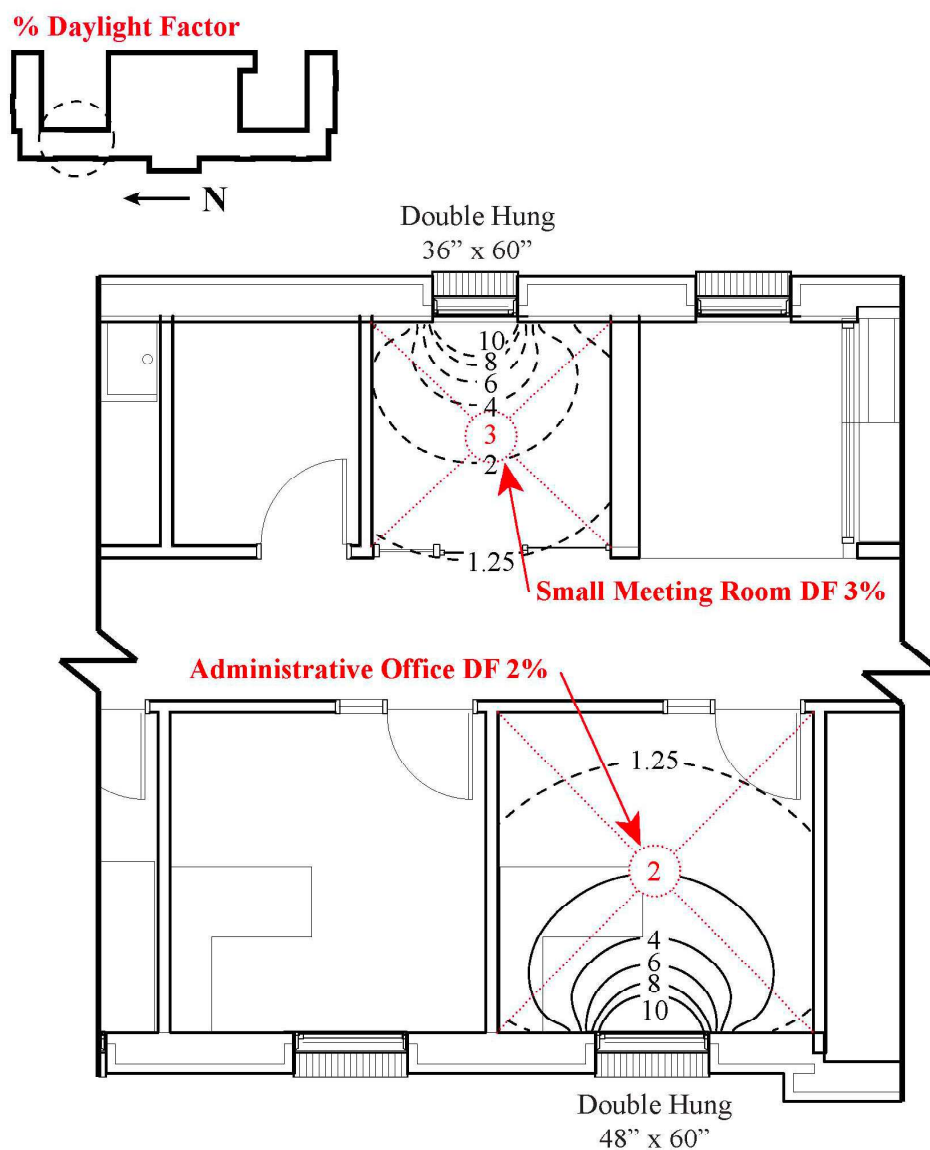
**Figure 9, Daylighting Contours of Typical Spaces**

Daylight Factors were estimated to be between 2-3% in the middle of the space for a typical room (see Figure 9). For a December noon overcast day this will produce an interior illumination of 13-20 foot-candles, and at noon in April an interior illumination of 42-63 foot-candles. Also, with the high gradient between the window and the back wall, glare could be an issue. Glare control should be considered for the perimeter spaces. Corridors were not included in the analysis but isolux patterns indicate that relighting the hallway from the offices is feasible. More in-depth calculations would be needed to verify corridor daylighting potential.
