Straub Hall  
University of Oregon

# **Report #1**

## **Envelope Renovation Study**

September 2012

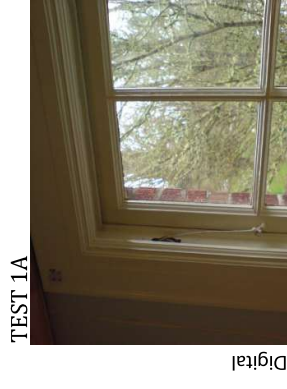
TEST 1A

Existing window before treatment

A: Infiltration noticed between sash and side jamb

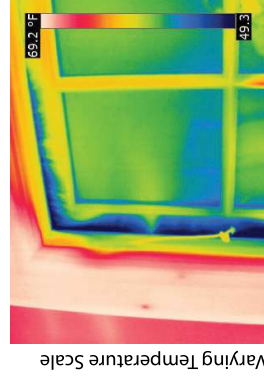
A: Need to seal counterweight pulley opening

The windows should be weather-stripped. If the existing sashes are to be used, it is recommended that retrofitted sashes be reinstalled into their original frames. Additionally, the counterweight cavity should be sealed as well as filled with insulation.

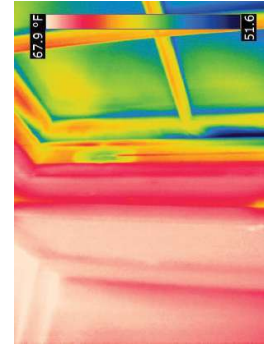
A: Exchanging sashes increased air leakage around window

The following chart (Figure 5) shows the results of the blowerdoor tests. These values are airflow rates at 50 Pa and do not represent rates at usual wind pressures. Note that in Test 2B leakage increased for an unknown reason. Using sashes from another window may potentially have been the cause for this increase; note that the sash used for the slip test were taken from a neighboring window and may not have had a good fit in the test window. It is recommended that retrofitted sash units be replaced into their original frames.

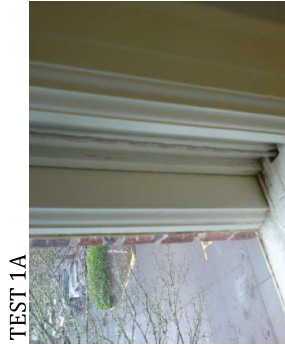
TEST 1A

Existing window before treatment

A: Noticeable infiltration in between check rails especially near the jamb

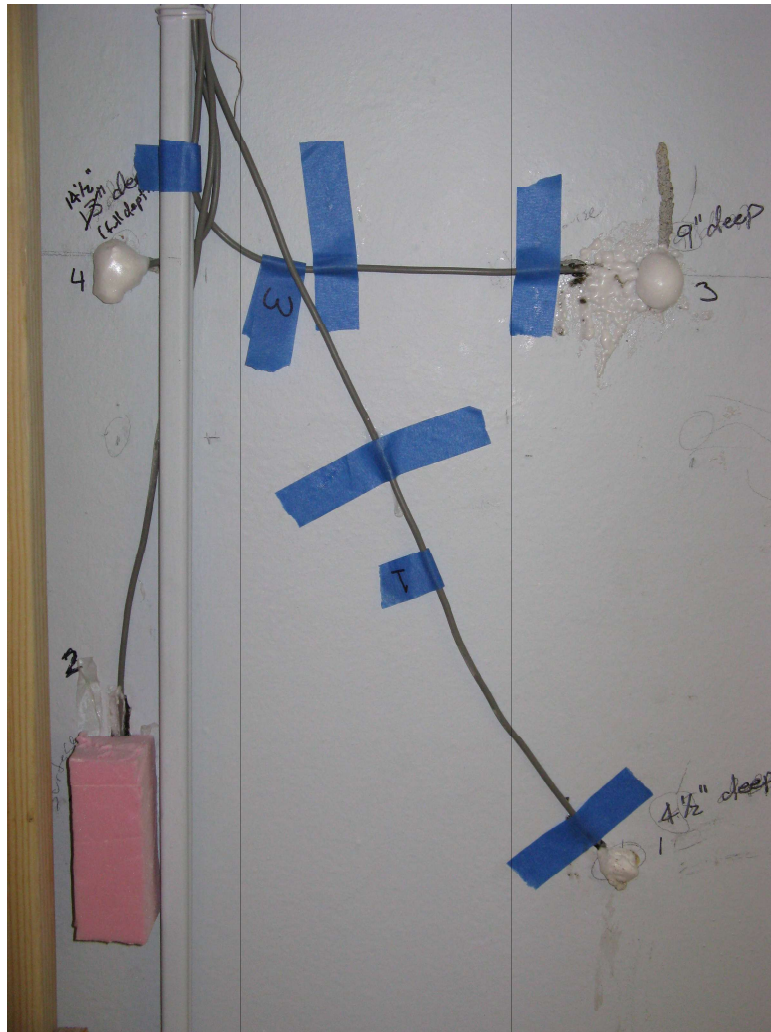
**Figure 6, Embedded Wall Monitoring Sensors**

Wall monitoring was conducted using HOBO dataloggers with thermistors embedded within the exterior wall (see Figure 6). Data was collected throughout the test period.
